# **Progress Report**

## **Argyle Central School District Capital Project and Energy Performance Project**

Report Number: #1  
Week Ending: June 15, 2018

SED Project #: 64-01-01-04-0-001-013  
64-01-01-04-5-002-007

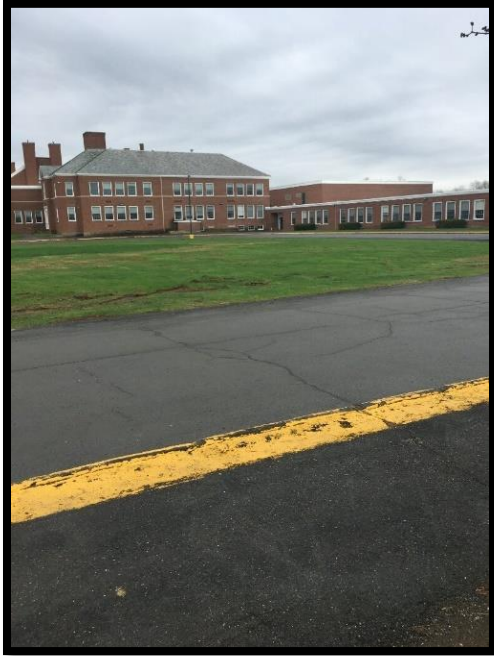
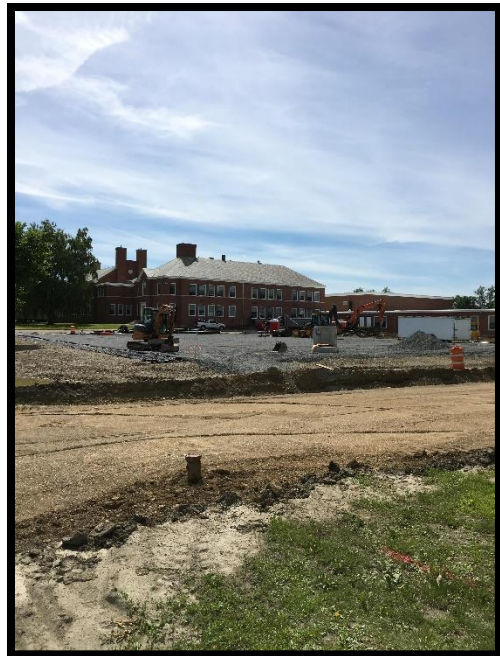
## Bus Loop & Athletic Field Reconstruction

- All major excavation for the future athletic courts has been completed, including grading, drainage, imported fill, and installation of light pole bases, along with the conduit for new light pole fixtures.
- The sitework subcontractor is awaiting arrival for the fence pole bases, which are anticipated to be received soon.
- Bus loop demolition work has also been substantially completed.

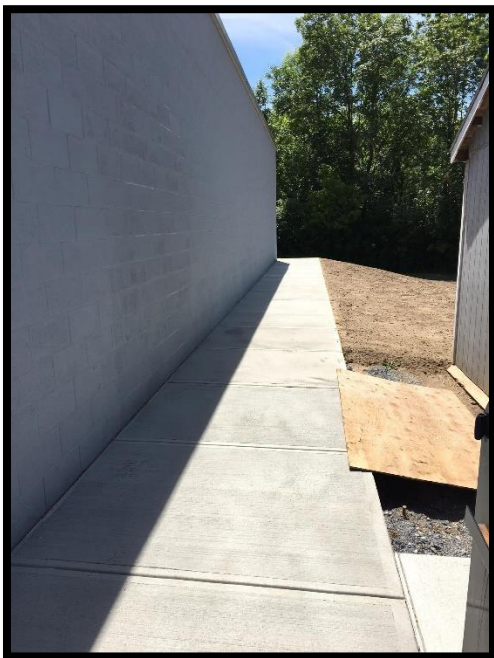
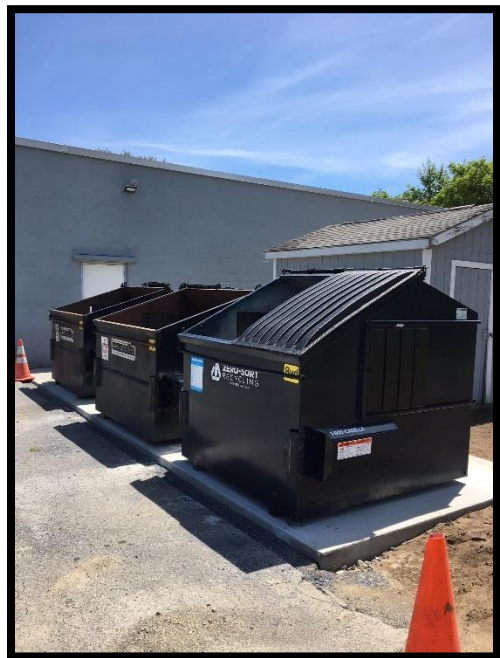
## ADA Sidewalk & Dumpster Pad

- The new concrete sidewalk around the Bus Garage has been completed, as well as the new dumpster pad. The sidewalk was re-routed to the North side of the Bus Garage, in order to avoid the existing fuel tank pad on the South side of the building, which presented some elevation and grade challenges. All disturbed areas of lawn have received topsoil and seed.
- Additional suspect asbestos pipe insulation (elbows) were discovered up near the roof level of the Bus Garage. The District's environmental consultant (Ambient) has notified that abatement of this asbestos at the ceiling level should be addressed before contractors begin proceeding with work associated with the new floor drain system.

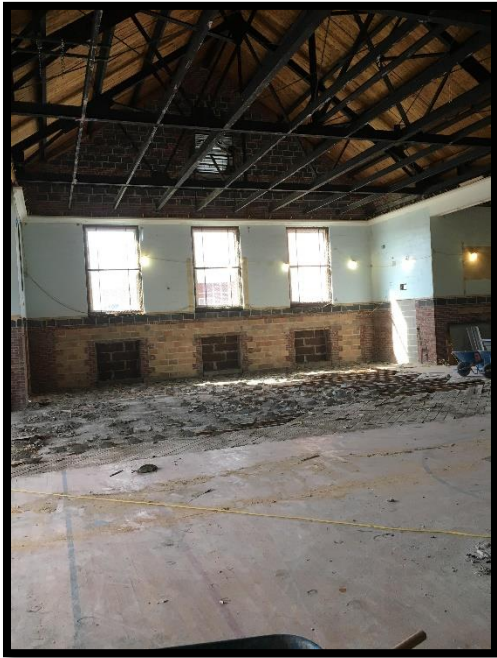
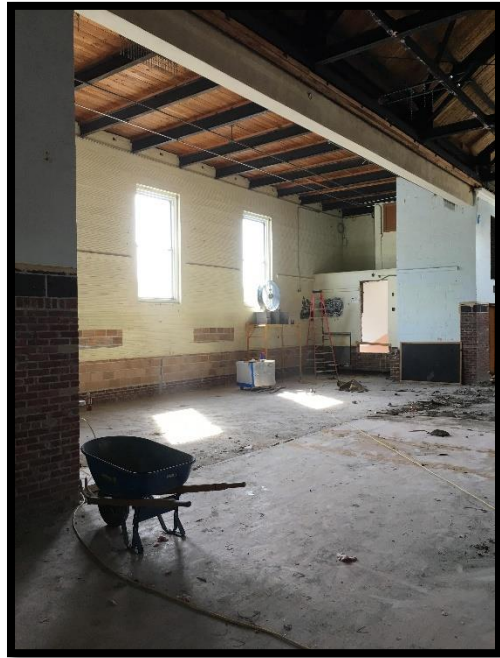
## Gymnasium Reconstruction

- Demolition of the stage, some wall coverings, ceiling, floor, and conference room within Gym 1000 is completed, along with asbestos abatement and proper removals of lead paint. Stairwells have been removed and are awaiting reconstruction.
- The General Contractor is awaiting feedback from Ambient regarding their ability to proceed with the installation of new structural members in the basement that will provide additional support for the renovated gym floor and new side partitional walls.

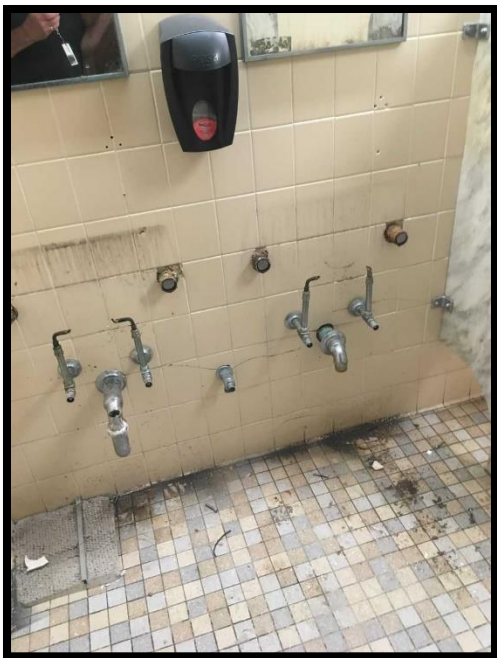
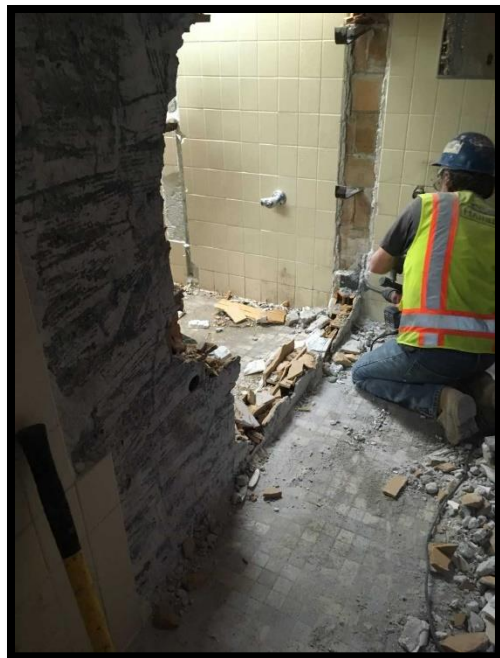
## Men's & Women's Bathroom Remodel

- The Men's and Women's bathroom are mostly demolished with all plumbing fixtures being removed and electrical circuitry feeds deenergized.
- While performing demolition in the bathrooms, the General Contractor came across suspect material and stopped their operations. Samples of the suspect material were later tested and came back with positive results for asbestos. Air samples indicated levels of asbestos within the bathrooms, but the corridor area came back with clear results. Despite these findings, the District's environmental consulting firm directed the surrounding corridor area to be secured off and the pile of outside debris, which did contain some level of asbestos, to be barricaded and posted with asbestos warning signs. Once proper variances were approved by the Department of Labor, abatement and removals of the material proceeded in a timely manner.

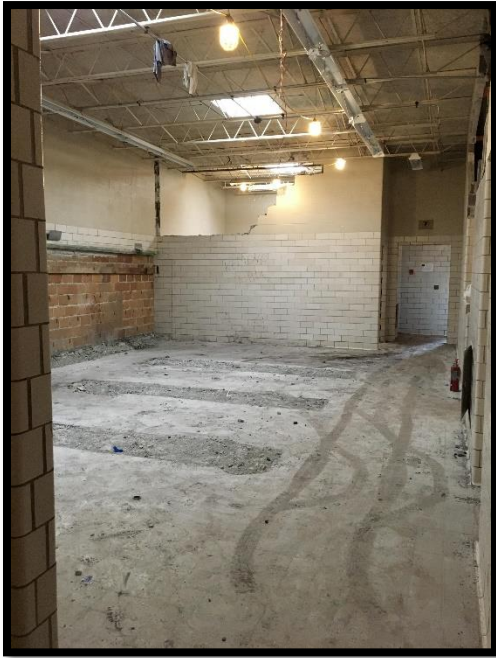
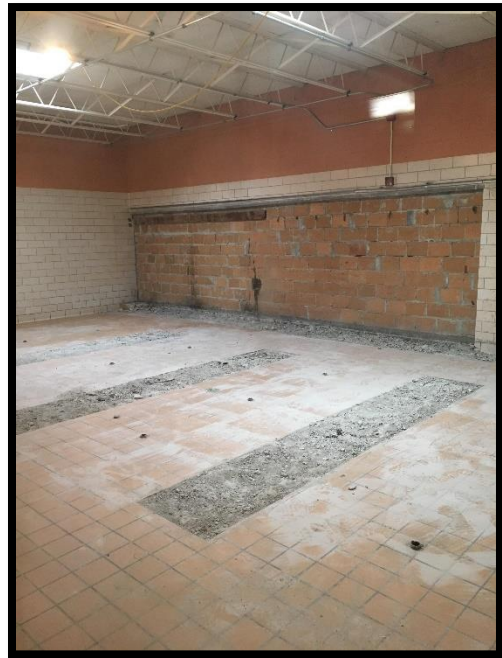
**Boys & Girls Locker Room Renovation**

- While performing demolition within the locker rooms, the General Contractor discovered suspect materials and stopped work for samples to be taken, which also confirmed the presence of asbestos containing materials.
- The Project Team is currently awaiting formal direction from the environmental firm as to how abatement and removals should take place within these spaces.

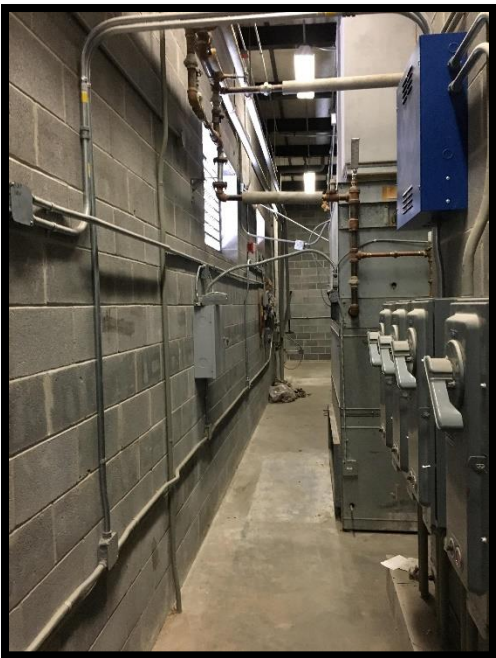
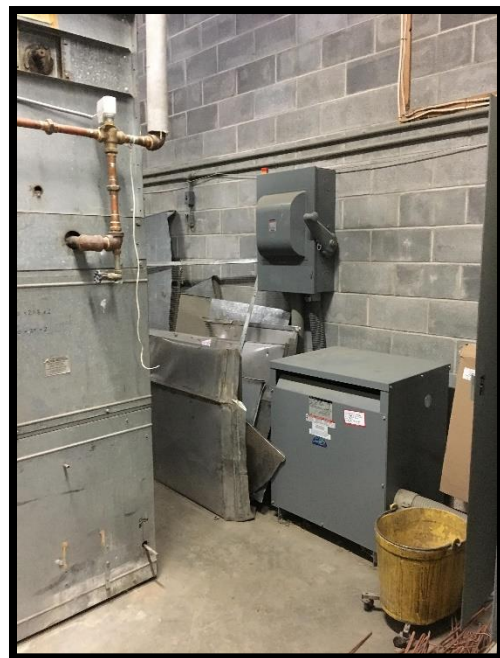
**Air Handling Alterations and Mechanical Work**

- The area above the old entry lobby has been completely cleared of debris and the masonry wall penetrations on the sides were modified to accept new installations.
- The old air handling unit in the basement zone beneath the gym has been completely broken down and stacked for easy removal once the access hole is completed by the General Contractor.

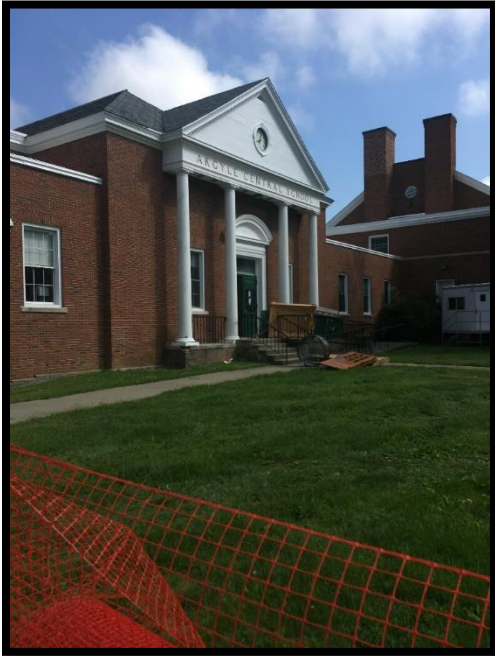
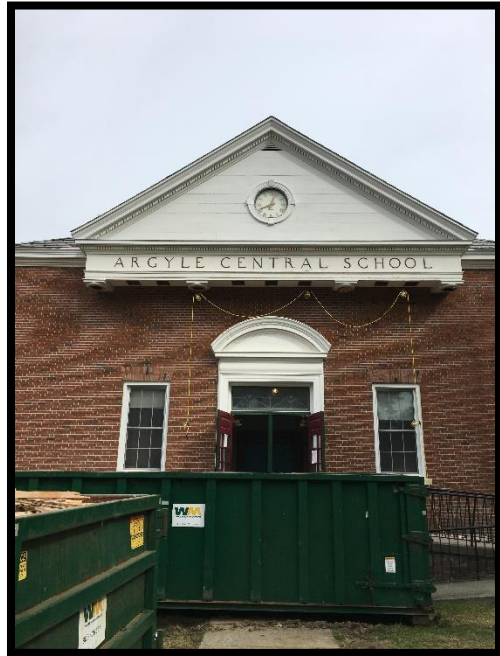
## Old Main Entry Renovations

- All columns and railings have been removed, as well as several exterior light fixtures.
- The General Contractor is awaiting direction as to how they can proceed with removing the existing ramp, given the presence of asbestos containing materials in the lower crawlspace that have an opening into the foundation area of the exterior stairs and ramp.

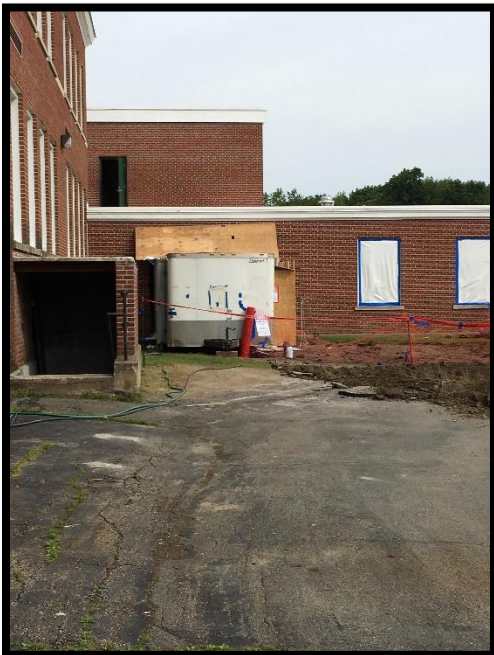
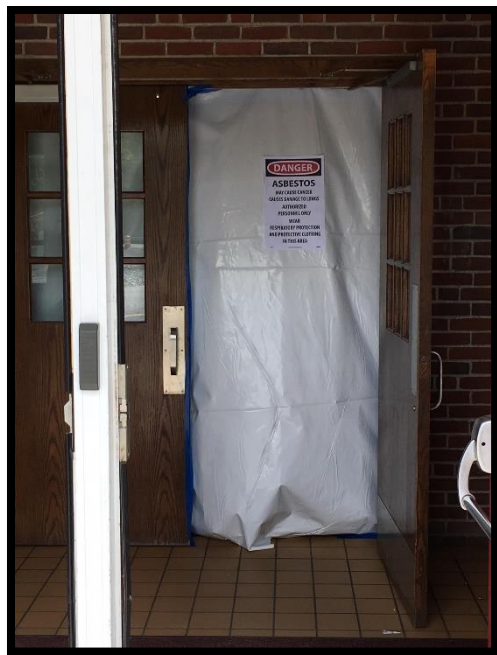
## Hazardous Materials Removals

- Ambient has discovered the presence of additional asbestos containing materials in several zones of the basement and crawlspace, including the area beneath the old gym and much of the crawlspace that runs within the mid-zone of the original building.
- Before construction activities commence in these spaces, Ambient must file a variance on behalf of the District and identify the respective abatement scope that needs to initially be completed.
